City of Claremore Inspection Summary Report - May 2009

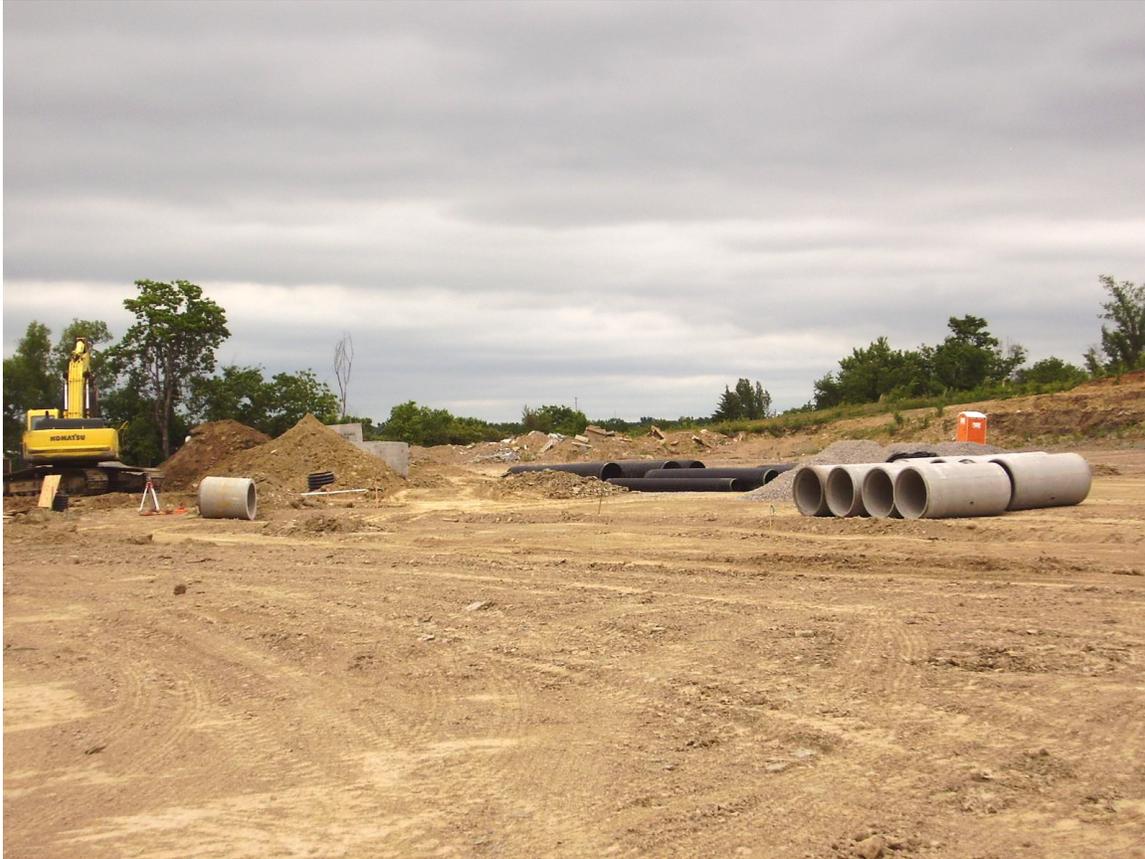
(Above) Contractor is continuing with the installation of storm sewer infrastructure. The contractor now has in place approximately 80% of the phase one storm pipe. There are several boxes which will need to be watched closely to insure that the proper seal is attained. You can see from the two pictures below that the proper boxes were either not ordered or shipped right and the contractor has had to both saw and hammer on these boxes to get the required pipe inside them. These can be fixed to attain a water tight seal. This is not just a less than perfect condition, but a poor one.

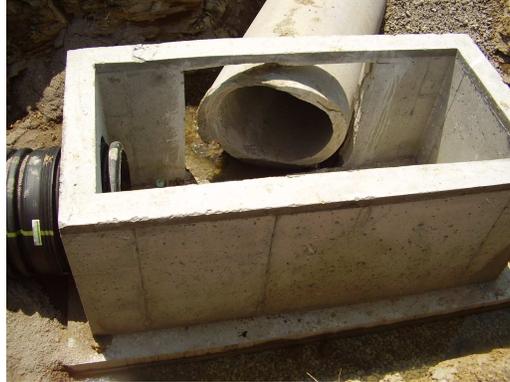
The picture below shows a junction box that has had the wall cut so severely that there is less than 6" of concrete left and is also cracked. We will air test all junction boxes and camera all lines prior to acceptance of the storm sewer. The contractor has done a good job of getting the required amount of bedding and backfill required by the specifications.

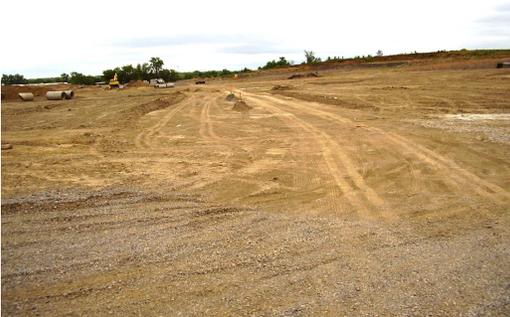
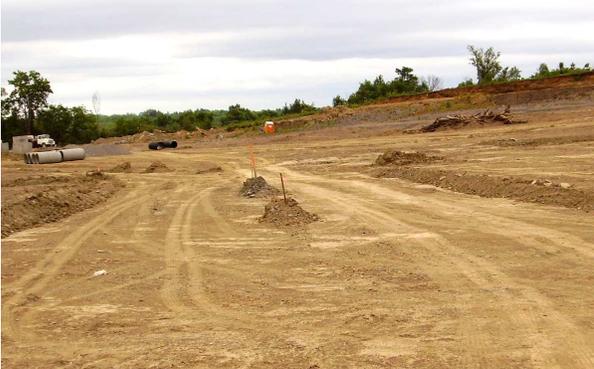
(Below) You can now start to see some areas where the beginning cuts are for the roads. The contractor has done a good job of compacting these areas and all areas where the storm sewer will cross under the proposed roads.

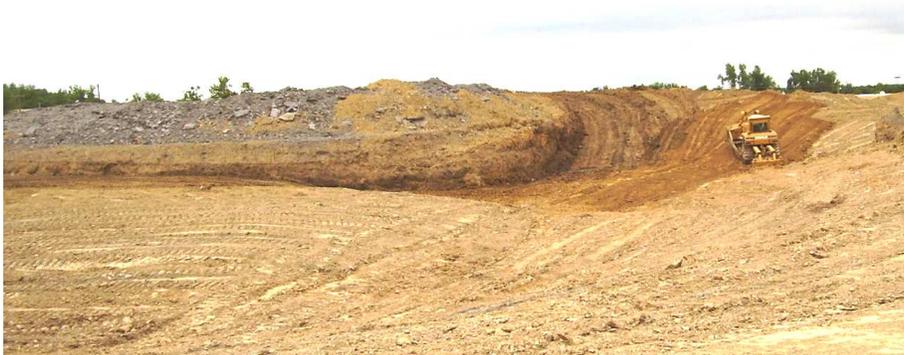
(Above) The contractor is beginning to shape the first of several on-site storm water ponds. The one pictured being built will be a part of the storm water system which will handle the water from east of Highway 66 to the west side of the existing hill.

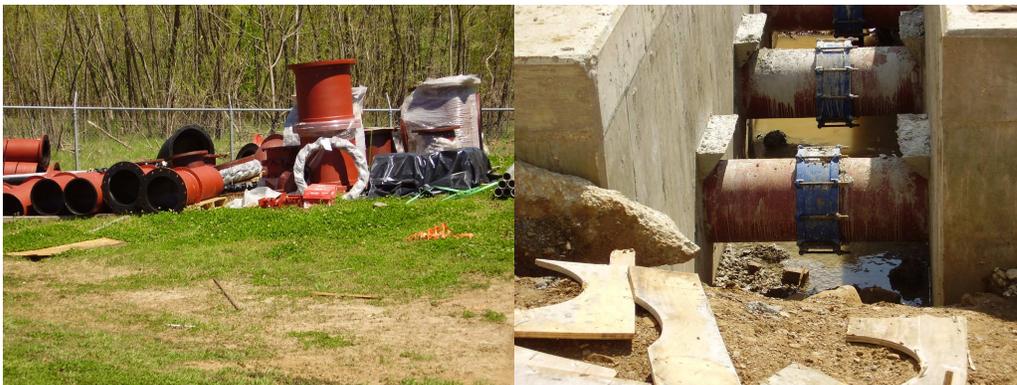
(Above left) All of the above fittings are now in place and the valve vaults are completed. (Above right) Piping is in place between the wet well and the valve vault on the right side of the picture. (Below) Electrical contractors are working both inside the building and on the east side installing the required equipment to operate the new force main.

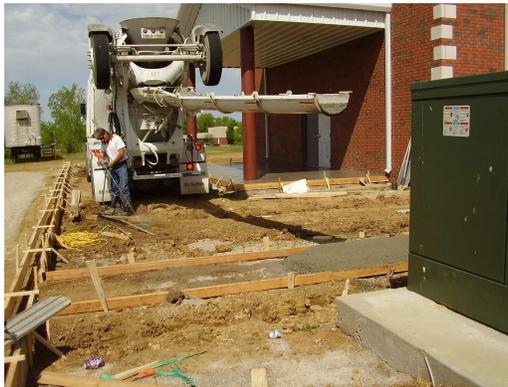
Rain has slowed down the driveway completion which was not finished until last week. Cleanup and landscaping still need to be completed to final this project.

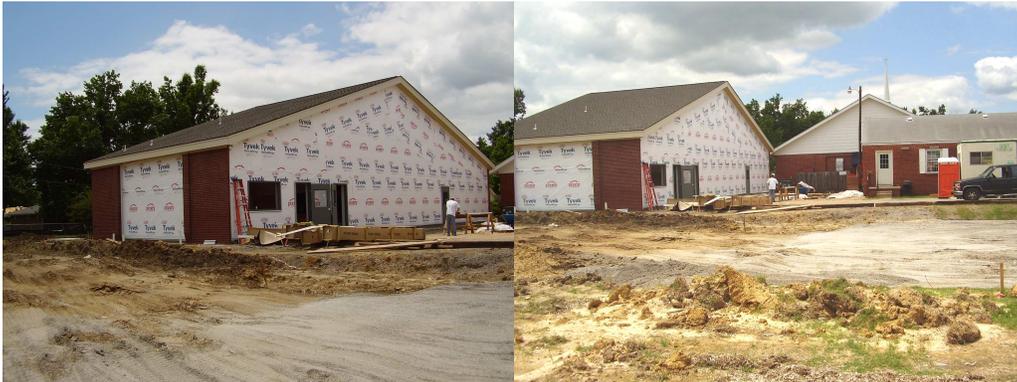
(Above left) Contractor has partially completed the brick façade on the new addition.
(Above right) This shows the new addition in relation to the existing structures. The one on the right side will be demolished during the second phase of construction which has yet to be permitted.

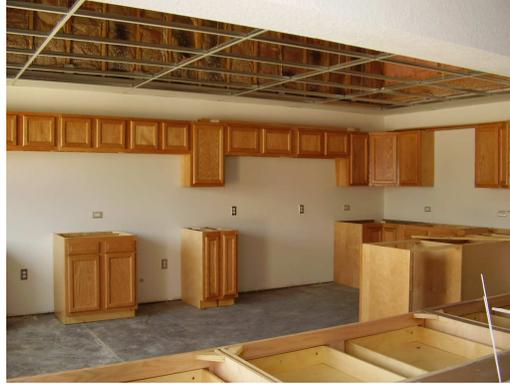
Inside the sheetrock, flooring and painting are 90% complete. Above you can see the mill work is ongoing with the cabinets being set and waiting on the tops to be installed. Several sections of ceiling tiles are missing in the ceiling grid where florescent light will be installed by the electricians.

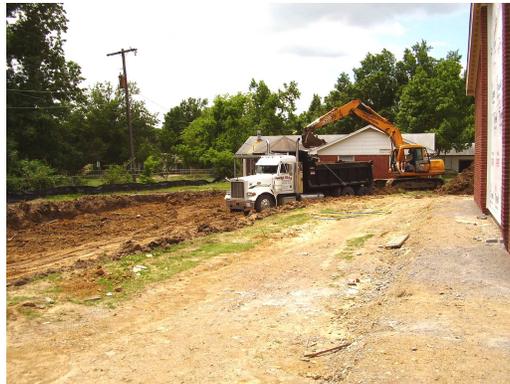
(Above) Contractor is cutting in the new road which will run on the south side of the new church addition. This area will also serve as their storm water detention area. You can see a house in the background which will remain in place. The proposed road will run on the north side of the existing house and the storm water will be channeled on the south side and both will exit on the west side of the property.

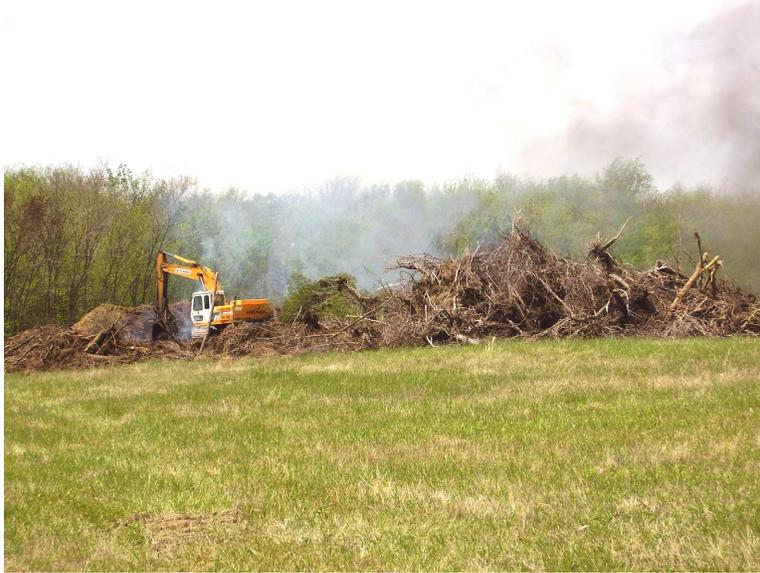
The church received a burn permit and has begun eliminating the piles they had from the clearing of the new church site and the remnants of the ice storm. We anticipate the new plans to be in for review later in the year.

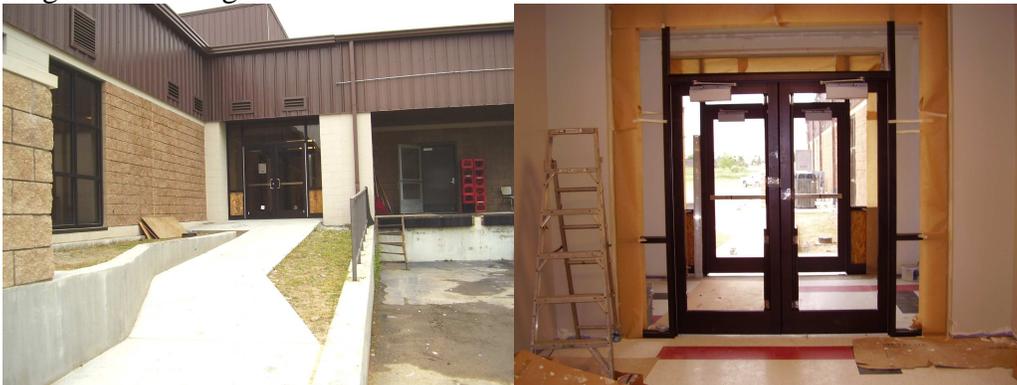
The contractor is working on the electrical outlets and fixtures. All the plumbing for the restrooms, flooring and painting have been completed. They still have some window issues which need to be dealt with but these are minor and should be completed in the next few weeks. (Above left is the area where the existing school on the right was joined to the new school on the left of the picture. The contractor did an excellent job of blending these two structures together. (Above right) This is the same door as on the right from the inside with plywood still in place.

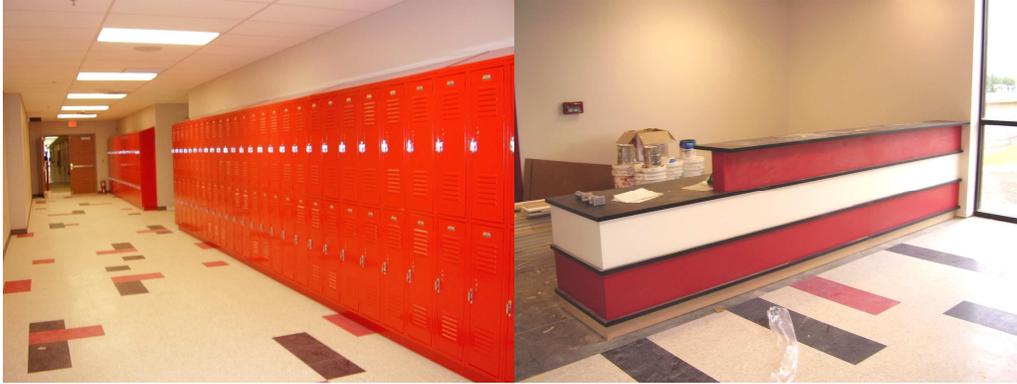
The contractor is finishing up with some small details and is planning on being completely finished with the project by June 15. (Below left) All the lockers have been installed and the contractor is finishing installing the baseboard in several areas. (Below right) The mill work has been completed in the receptionist area with less than 10% left to be completed in the whole school.

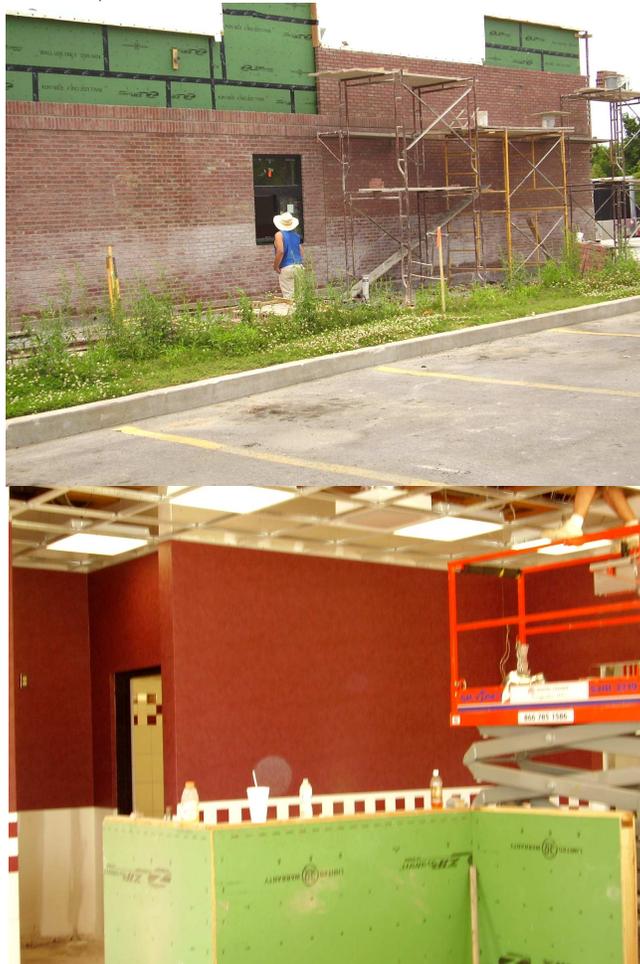
(Above top) Contractor is finishing up with the brick façade around the drive thru window. Approximately 85% of the brick work is done and 70% of the concrete work has been completed. (Above lower) Mechanical contractors are installing duct work and mill work, painting, tile and other trades are continuing inside.

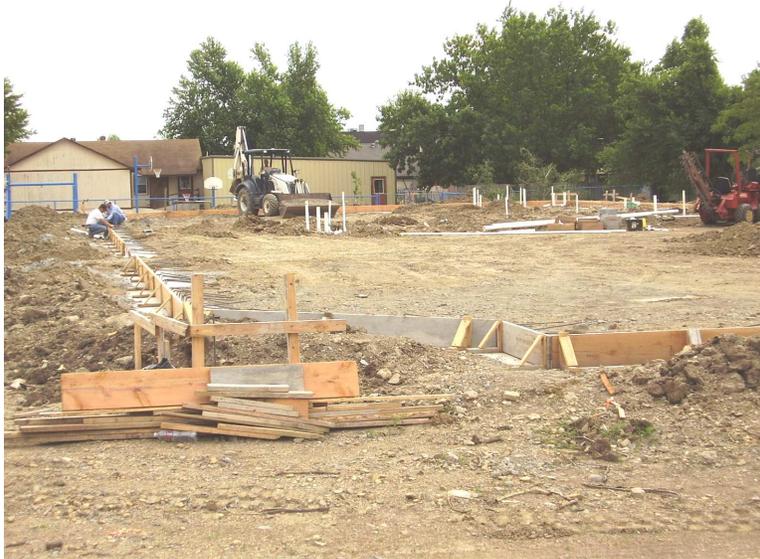
Contractor has placed footings and piers and is installing all the plumbing which will be under the slab. Concrete work for the slab should be placed in the next two weeks.

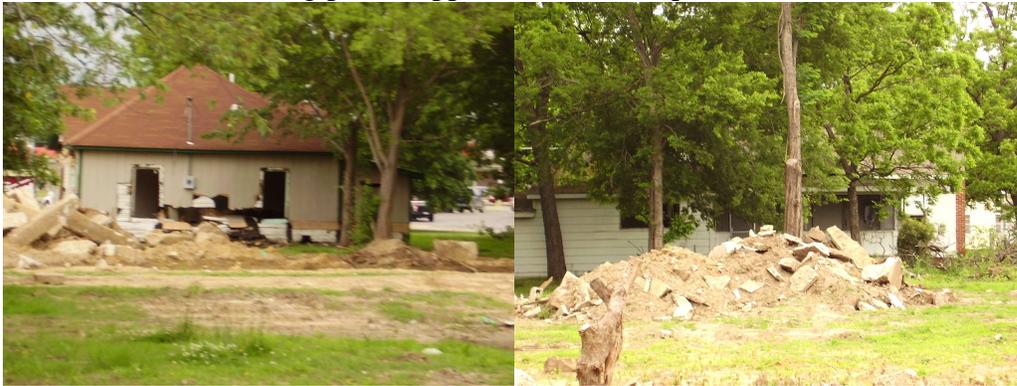
Work is continuing with the demolition of existing structures. There are two structures left to be demolished and some debris to be cleaned up. We are waiting on plans to be submitted and a building permit application to be requested.
